ALL THAT REMAINS

THE TRADITIONAL ARCHITECTURE AND
HISTORIC ENGINEERING STRUCTURES
RICHARD B. RUSSELL MULTIPLE RESOURCE AREA

APPENDIX A: THE INVENTORY

PREPARED BY ARCHEOLOGICAL SERVICES BRANCH, ATLANTA
NATIONAL PARK SERVICE

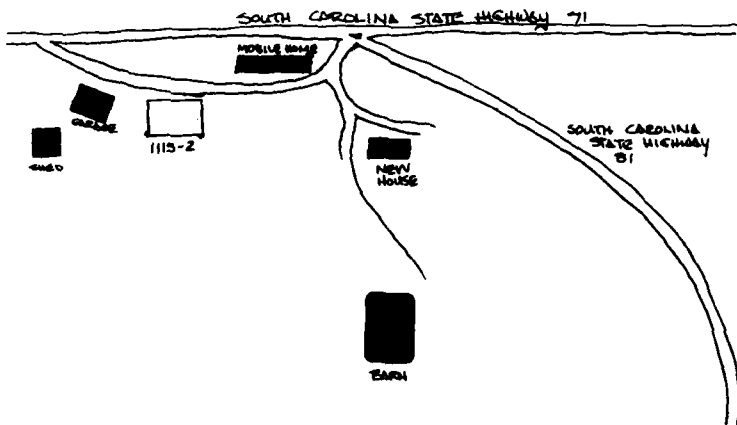
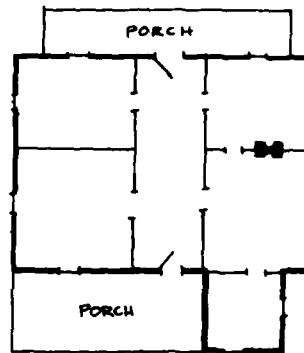
15 CONDITION 70 <input type="checkbox"/> EXCELLENT 71 <input type="checkbox"/> GOOD 72 <input type="checkbox"/> FAIR 73 <input checked="" type="checkbox"/> DETERIORATED 74 <input type="checkbox"/> RUINS 75 <input type="checkbox"/> UNEXPOSED 76 <input type="checkbox"/> ALTERED 82 <input type="checkbox"/> DESTROYED 85 <input type="checkbox"/> DEMOLISHED		16 INVENTORIED BY John L. Hopkins, Emily J. Harris		AFFILIATION Historic American Buildings Survey		DATE May 1, 1979		17 DESCRIPTION AND BACKGROUND HISTORY INCLUDING CONSTRUCTION DATE(S); HISTORICAL DATE(S); PHYSICAL DIMENSIONS MATERIALS EXTANT EQUIPMENT AND IMPORTANT BUILDERS ENGINEERS ETC One-story, balloon frame house with rear addition, 43' (three bays) X 52' (three bays). Hip roof with two front gables, gable roof on addition, covered with asphalt shingles over wooden shingles, boxed cornice; gable ends covered with shingles with diamond shaped lattice vents, clapboard and weatherboard siding, 9x9 sash windows; cement front porch, collapsed rear porch; foundations of brick and cinderblock piers. Central hall plan, two rooms wide one room deep, with one room addition. Interior brick chimney; interior sheathed throughout. Much siding has been removed from the structure, resulting in increasing deterioration, including the collapse of the floors. Preservation could not be easily accomplished. The structure is associated with a post and frame garage, CA. 1950, and a balloon frame shed, CA. 1940, both quite overgrown. The association of the structure with a house trailer, modern house, and large barn nearby is unknown.

This structure is typical of late nineteenth and early twentieth century houses in this region, although there are relatively few like it in the project area. Due to the salvage of much original fabric, there appears to be little potential for preservation.

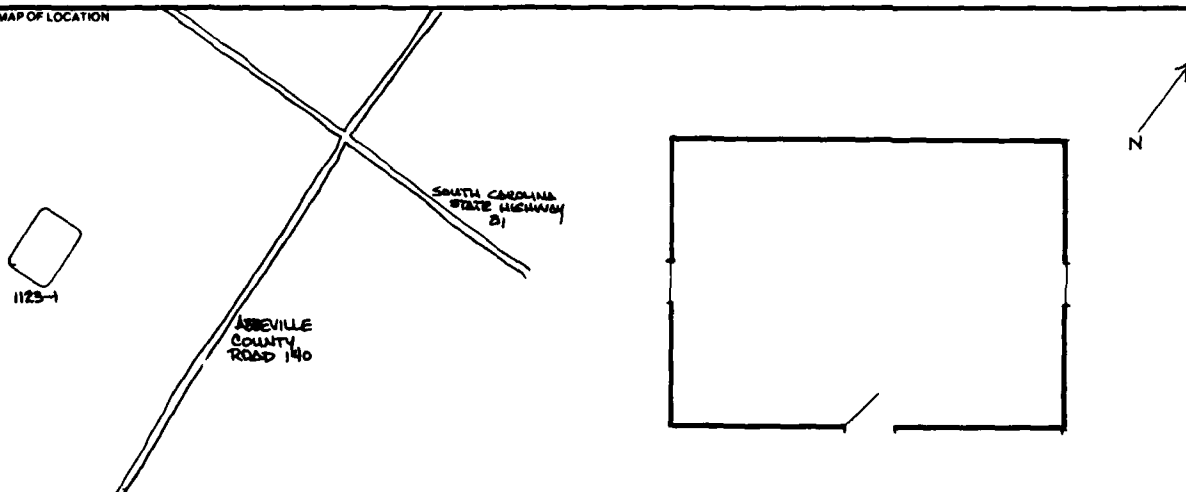
14 UTM ZONE 17		EASTING 351780		NORTHING 3782540		SIGN		SCALE 1:24		QUAD NAME Latimer, S.C.					
15 CONDITION 70 <input type="checkbox"/> EXCELLENT 71 <input type="checkbox"/> GOOD 72 <input checked="" type="checkbox"/> FAIR 73 <input type="checkbox"/> DETERIORATED 74 <input type="checkbox"/> RUINS 75 <input type="checkbox"/> UNEXPOSED 76 <input type="checkbox"/> ALTERED 82 <input type="checkbox"/> DESTROYED 85 <input type="checkbox"/> DEMOLISHED															
16 INVENTORIED BY John L. Hopkins, Emily J. Harris		AFFILIATION Historic American Buildings Survey		DATE May 1, 1979											
17 DESCRIPTION AND BACKGROUND HISTORY INCLUDING CONSTRUCTION DATE(S), HISTORICAL DATE(S), PHYSICAL DIMENSIONS, MATERIALS EX-TANT, EQUIPMENT AND IMPORTANT BUILDERS, ENGINEERS, ETC. One story, balloon-frame dwelling, 22'3" (one bay) X 16'4" (one bay). Gable roof covered with sheet metal; clapboard siding, windows of no lights previously covered with board shutters; foundations of fieldstone granite piers. Plan is one room, no chimney, hole in end wall for stove flue. The structure has been subject to salvage (not evident in photographs) and the main structural members are deteriorating rapidly.

This is the only one-room cabin in the project area, and probably served as a hired man's house. Increasing decay of the structural members and ongoing salvage are likely to result in the collapse of this building.

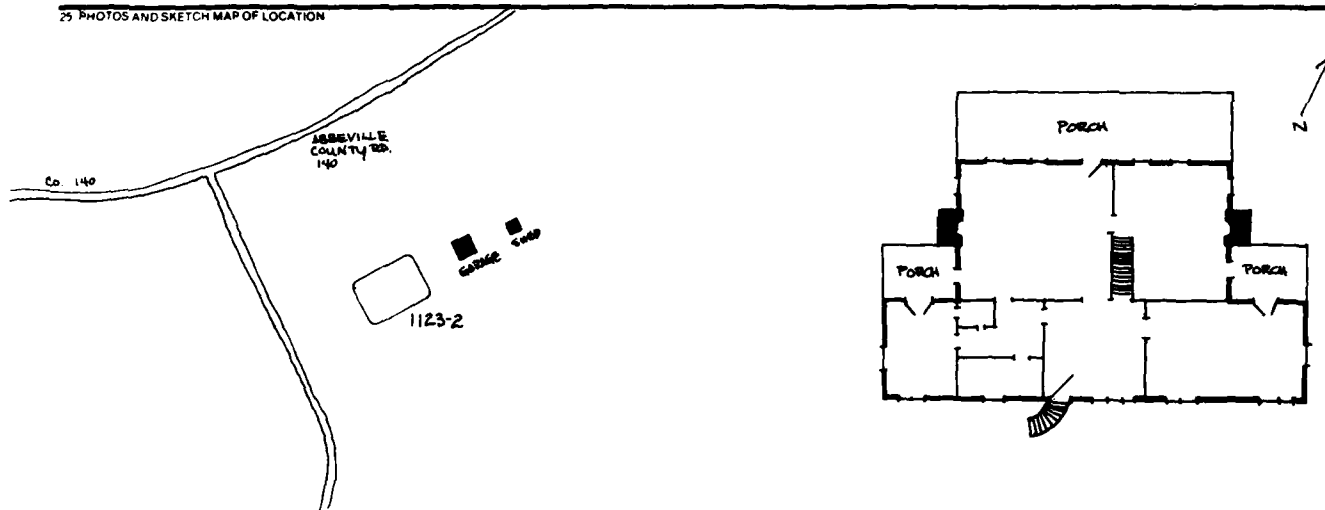
28 CONDITION 70 EXCELLENT 71 GOOD 72 FAIR 73 DETERIORATED 74 RUINS 75 UNEXPOSED 76 ALTERED 77 DESTROYED 78 DEMOLISHED										29 INVENTORIED BY John L. Hopkins, Emily J. Harris									
30 AFFILIATION Historic American Buildings Survey										31 DATE May 1, 1979									
32 DESCRIPTION AND BACKGROUND HISTORY INCLUDING CONSTRUCTION DATE(S) HISTORICAL DATE(S) PHYSICAL DIMENSIONS MATERIALS EXTANT EQUIPMENT AND IMPORTANT BUILDERS ENGINEERS ETC Two-story, sawn frame dwelling with balloon frame additions (CA. 1930-1940), 63' (seven bays) X 45' (three bays). Gable roof, shed roofs on additions, covered with asphalt shingles; asbestos siding, exterior brick chimneys laid in common bond, 9x9 sash windows; two-story front porch (CA. 1870), with four columns; foundations of cement blocks, previously brick piers. Original plan two rooms with central hall stair, porch additions on front and sides, shed addition of four rooms across rear. Interior finish of lath and plaster, original chair rails, dado paneling, and mantels in place. This structure is on the verge of collapse due to extreme deterioration, making preservation or restoration nearly impossible. The structure is associated with a garage and privy (CA. 1930-1940), both extremely deteriorated and overgrown.

This structure is one of the few examples of an antebellum plantation house in the project area. It is one of two structures in the project area with lath and plaster walls, and contains rare examples of original interior finish. It is the only house in the project area with a two-story colonnaded porch, a rare feature in this region. Preservation of this building would be extremely difficult due to its advanced deterioration.

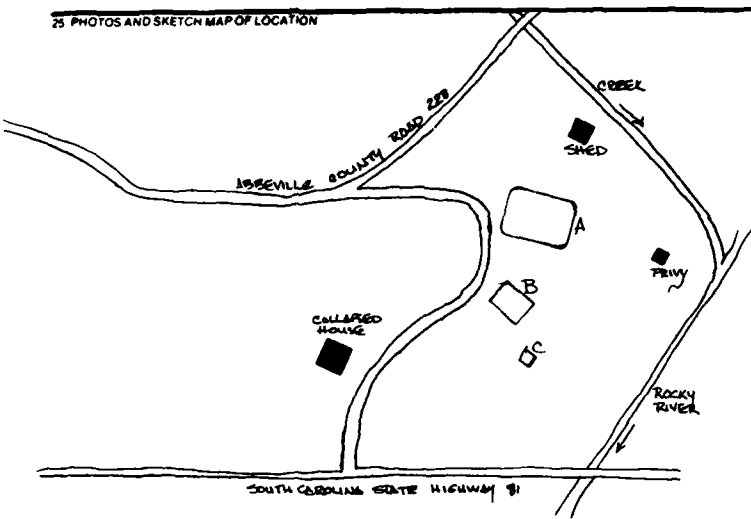
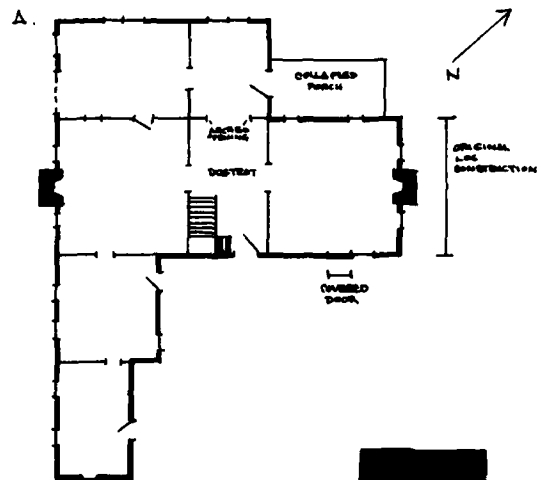
One and one-half story log dogtrot house with balloon frame additions to front and rear and enclosing dogtrot, 50' (four bays) X 67' (seven bays). Gable roofs covered with asphalt shingles over wooden shingles, boxed cornice; massive logs hewn on four sides with one-half dovetail joinery, frame additions covered with clapboard, collapsed front porch, detached exterior brick chimneys laid in common bond at ends of log section 9 x 6 sash windows; foundations of fieldstone granite piers. Original plan was two rooms with dogtrot, additions create L-shaped central hall plan of six rooms. Interior finish is sheathed throughout, with some original wainscot in place, suspended chimney in rear addition. Due to vandalism and extreme deterioration, this structure is in poor condition. The potential for preservation or restoration appears to be quite limited. The structure is associated with a collapsed frame house and a frame barn (AB1227-B), and a post and frame well house (AB1227-C), both extremely

Although this structure is extremely deteriorated, the interior and exterior finish that remain intact reveal both important construction techniques and changes made over time. The building is an excellent example of early log construction, displaying superb one-half dovetail joinery of massive hewn logs. The frame additions and enclosed dogtrot exemplify the adaptation of an early structure to later styles and needs for expansion. Although this structure is outside the acquisition area, it has been included in this inventory because of its historic merit and proximity to the acquisition line.

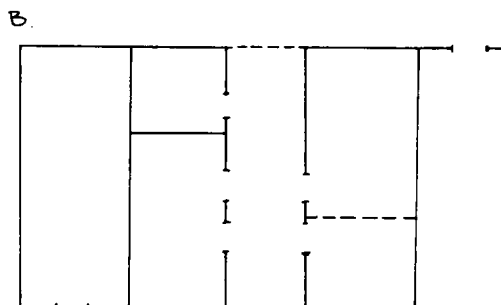
This structure is a good example of a post Civil War cattle or horse barn. The hewn frame members of the structure were probably incorporated from an earlier structure. This barn appears to have been associated with a later frame house, CA. 1875-1885, now collapsed. Although this structure is outside the acquisition area, it has been included in this inventory because of its relationship to Site AB1227-A.

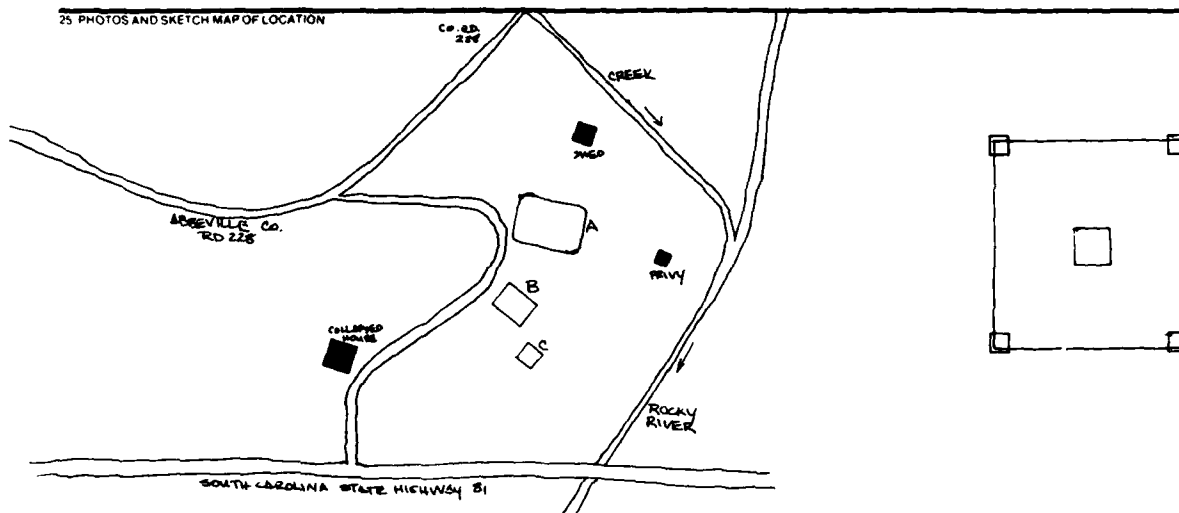
This structure is unusual in the use of hewn posts. It is likely that these posts were incorporated from an earlier structure, and that this well house was contemporary to a later frame house, CA. 1875-1885, now collapsed. Although this structure is outside the acquisition area, it has been included in this inventory because of its relationship to site AB1227-A.

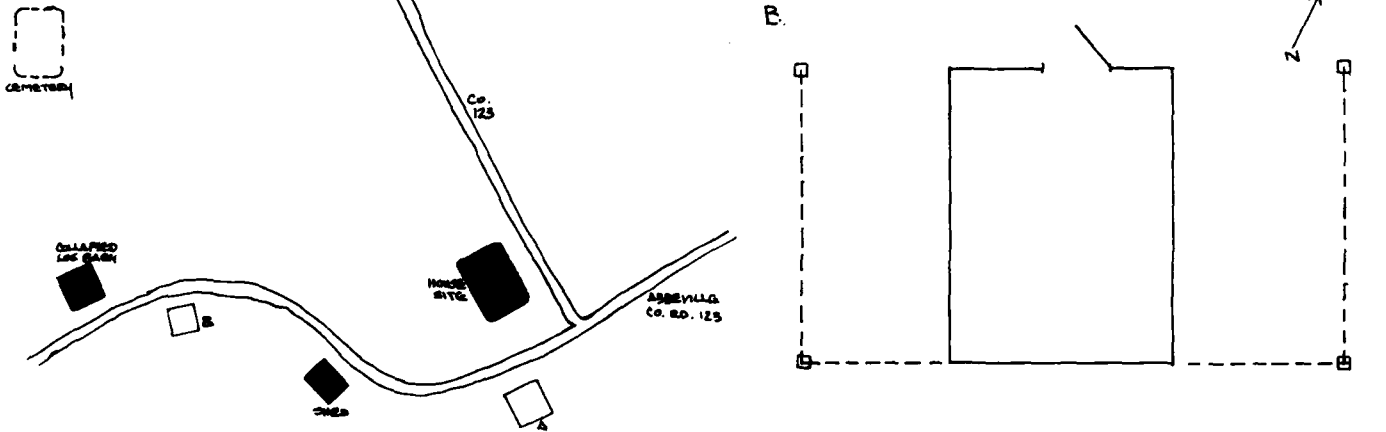
This small barn is a typical example of a late nineteenth century barn of which many examples exist throughout the project area and surrounding region. The significance of this building has been greatly undermined by the loss of the older, major buildings of this complex.

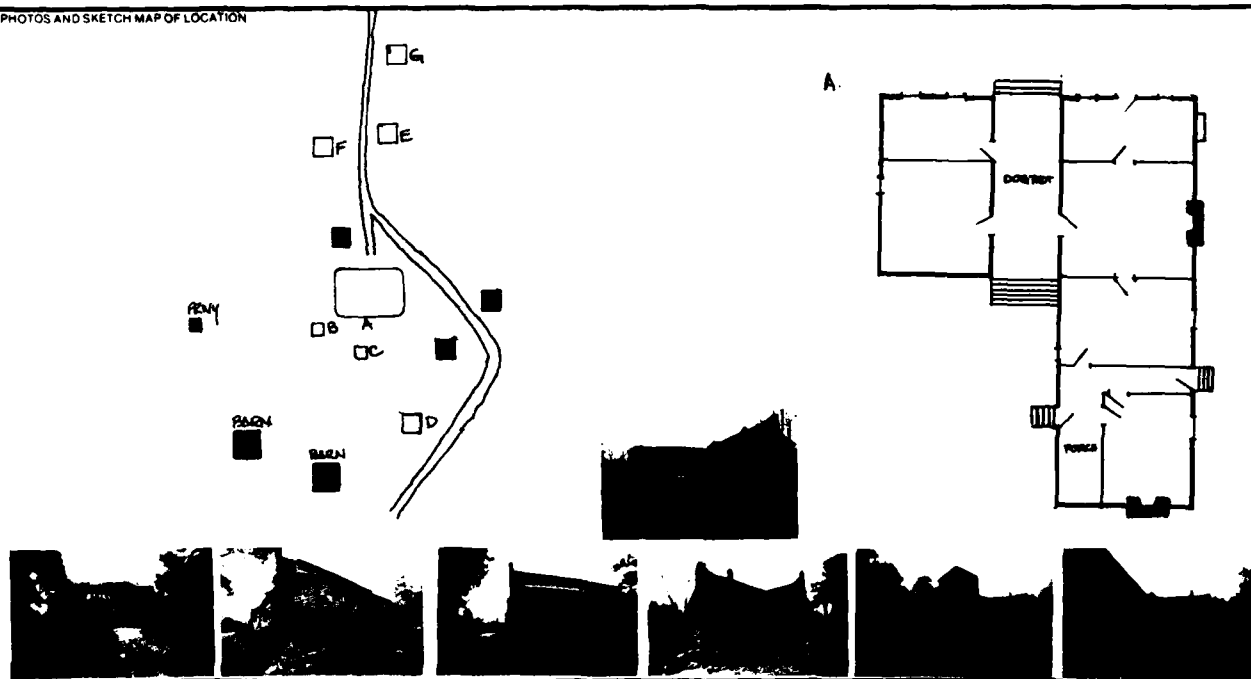
16 INVENTORIED BY John L. Hopkins, Emily J. Harris																				AFFILIATION Historic American Buildings Survey																				DATE May 1, 1979																			
17 DESCRIPTION AND BACKGROUND HISTORY (INCLUDING CONSTRUCTION DATE(S), HISTORICAL DATE(S), PHYSICAL DIMENSIONS, MATERIALS, EXTANT EQUIPMENT, AND IMPORTANT BUILDERS, ENGINEERS, ETC.) Two-story log dog-trot house with frame additions; 47' (four bays and dogtrot) X 60' (five bays). Gable roofs covered with sheetmetal, boxed eaves. One-half dovetail log joinery, clapboard siding on additions, boxed eaves, 6x6 sash windows, exterior brick chimneys laid on fieldstone foundations, original hardware or hand-forged replacement hardware in place throughout; foundations of fieldstone granite piers. Original plan of one room on either side of dogtrot; present plan two rooms deep on each side of dogtrot, with rear wing; original roof raised to its present height by addition of three logs to walls. This structure is in good condition with little damage to the fabric from deterioration and the preservation of this structure could be easily accomplished. Associated with this structure are six outbuildings: (b) smokehouse, CA. 1810-1820; (c) well house, CA. 1900; (d) corn crib, CA. 1880; (e) blacksmith shop, CA. 1850; (f) garage, CA. 1930-1940; (g) garage, CA. 1930. All of these associated structures are maintained at present and range from good to fair condition.

Composed of massive hewn logs with one-half dovetail joinery. This well preserved farmhouse is an excellent example of the construction skill of the early settlers of Abbeville County. This is certainly the most impressive log dwelling in the project area, if not in the whole of Abbeville County. The farm has been in the possession of the Hutchison family since 1877, though the original two buildings may date from as early as CA. 1810-1820.

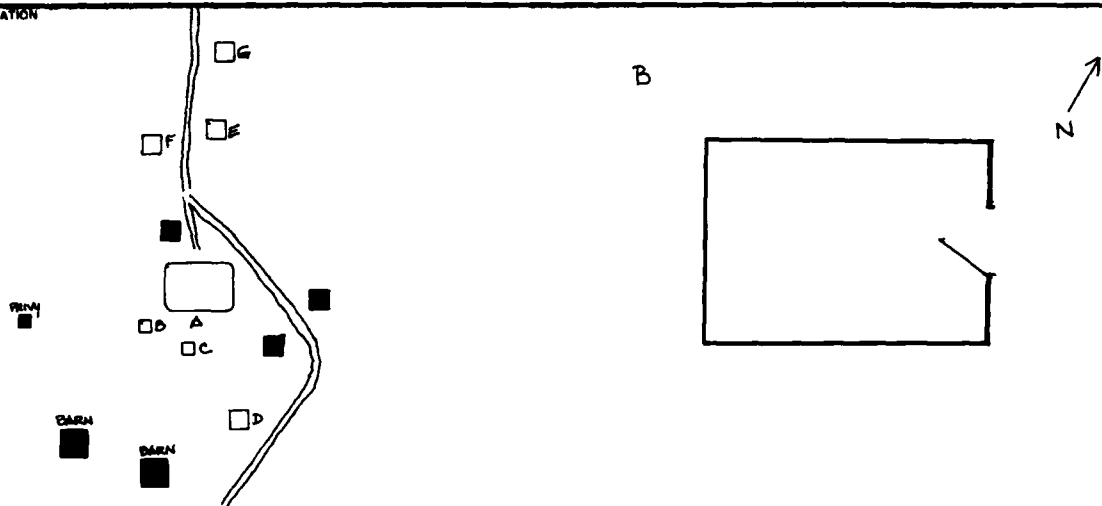
This small smokehouse is possibly the only outbuilding left standing from the original Hutchison Farm Complex. The log construction with one-half dovetail joinery indicates that it was built during the same period as the Hutchison house, Site ABI301-A, CA 1810-1820.

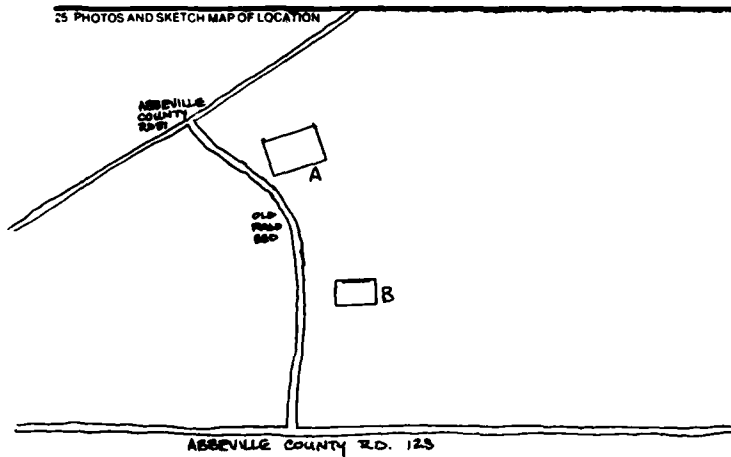
25 PHOTOS AND SKETCH MAP OF LOCATION

Significance This structure is a fine example of a post-civil war homestead dwelling. The front door with sidelights is an unusual feature in the project area, and even more unique is the small cupboard on an exterior wall, where there was previously a porch. This structure was recorded as part of the Hutchison Farm Complex (AB1301), although this house site and associated barn lie outside the acquisition line of the Russell Project.

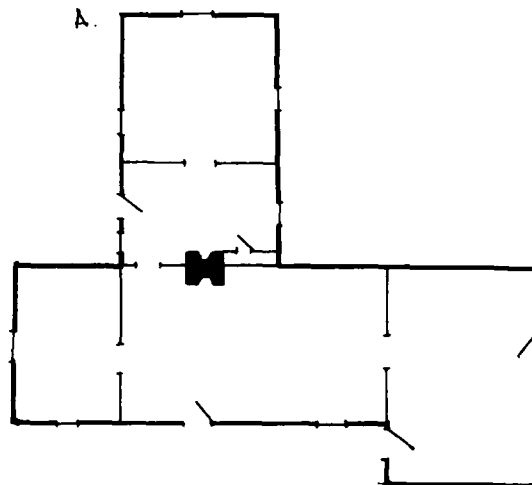
One-story, balloon-frame house; 44' (four bays) x 48' (four bays). Gable roofs covered with sheetmetal; clapboard siding, boxed eaves, windows covered with board shutters front door with sidelights, small exterior cupboard with five shelves; foundation of fieldstone granite piers. Interior inaccessible. Central chimney of brick laid on fieldstone granite foundations. This structure has been used for hay storage, resulting in the collapse of its floors. The potential for preservation of the structure therefore appears to be limited. The structure is associated with a small log dogtrot barn (site AB1301-2B).

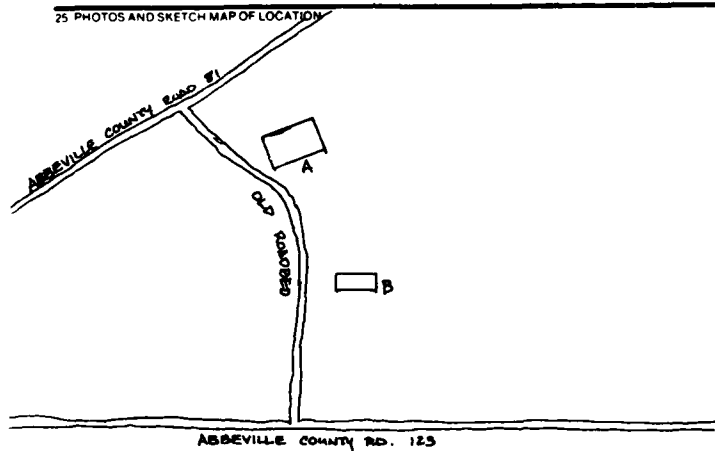
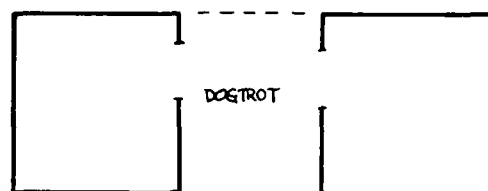
B.

Significance This structure exemplifies a unique form of log barn construction, not seen in the project area or in the surrounding region. Although the building has settled considerably, it continues to be a utilitarian farm structure of unique integrity. Informant evidence indicates that the barn was built sometime between 1914 and 1917, thus revealing the survival, or perhaps imitation, of traditional log construction techniques in the early twentieth century. This structure was recorded as part of the Hutchison Farm Complex (AB1301), although this barn and its associated house lie outside the acquisition area of the Russell Project.)

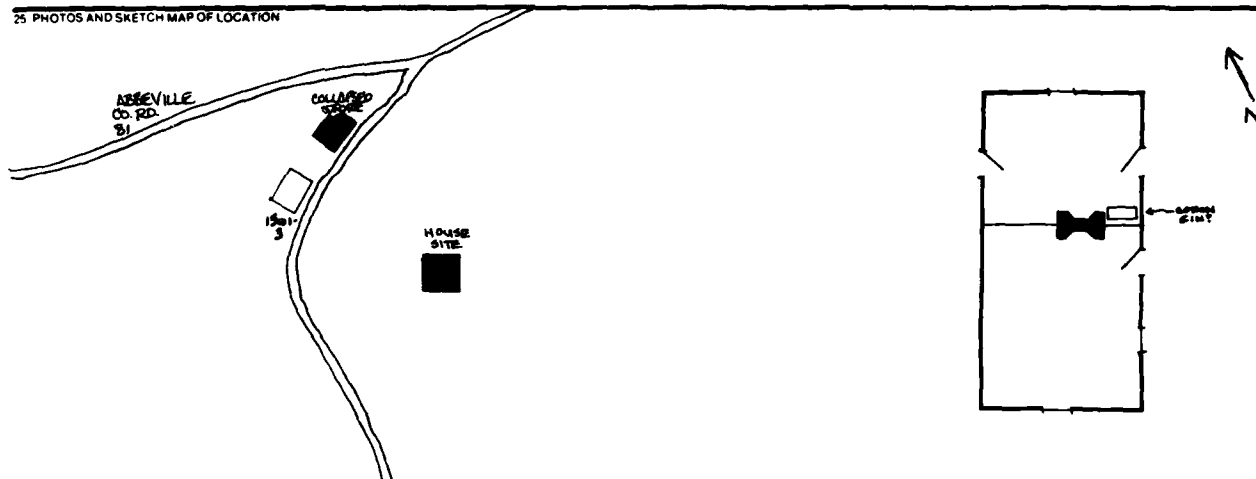
25 PHOTOS AND SKETCH MAP OF LOCATION

Significance This structure is one of the few that can be positively identified as a post-civil war hired man's dwelling in the project area. It is the only surviving part of a complex of buildings which included a house and a small store, and was associated with other nearby farms, few of which still exist. This structure was recorded as part of the Hutchison Farm Complex (AB1301), although it lies outside of the acquisition area of the Russell Project.

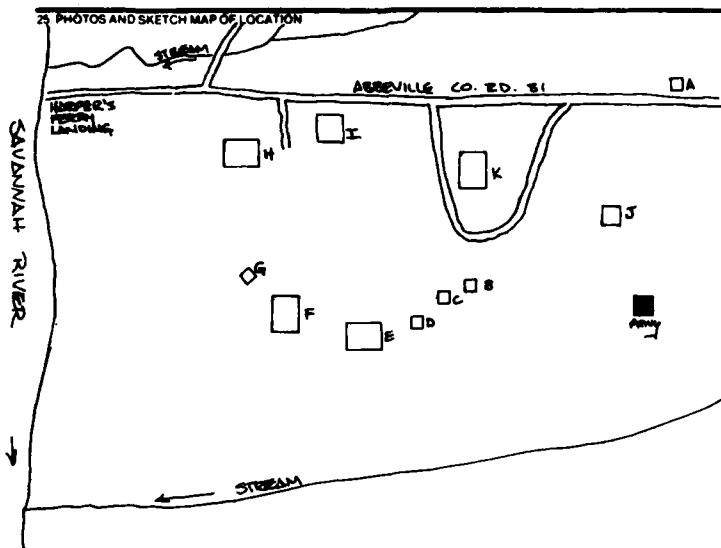
Significance The saddlenotch log joinery in this structure indicate that it was build CA. 1900. It represents the survival of traditional log construction in the early twentieth century. The structure was part of the larger Harper Farm complex, which originated as an early nineteenth century plantation. The complex includes structures of different periods; illustrating the continual evolution of the Southern farm. Several structures in the complex are of unique architectural character. The complex, associated with the site of Harper's Ferry, played a central role in the economic development and history of the project area.

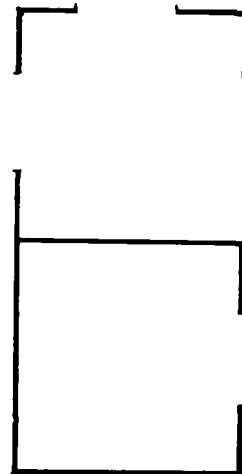
B

This structure is a unique example of a combination well house, ladder and buttry and is one of three embankment structures in the project area. See site AB1304-A for significance of complex.

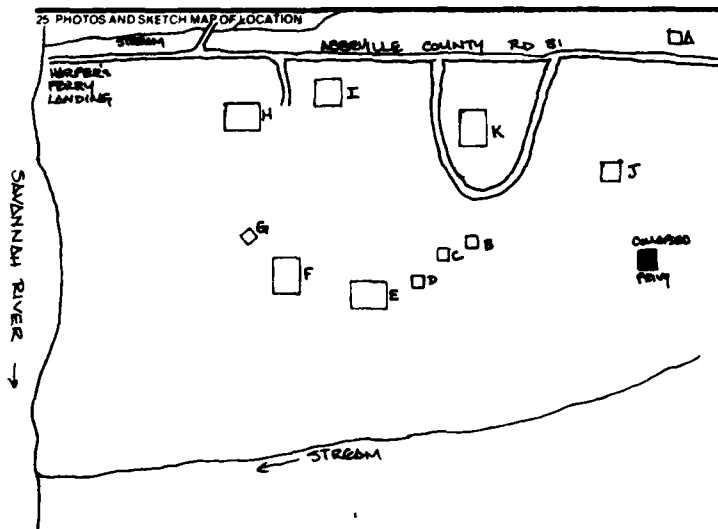
C.

One-story, balloon frame well or generator house. Gable roof covered with sheetmetal; vertical sheathing and clapboard siding, lattice door. One room containing concrete foundation for heavy equipment, pieces of electrical equipment on walls. The structure is well preserved. It is one of ten structures remaining from the Harper Farm Complex (See Site AB1304-A for general comments).

NO MEASUREMENTS TAKEN
OF THIS STRUCTURE.

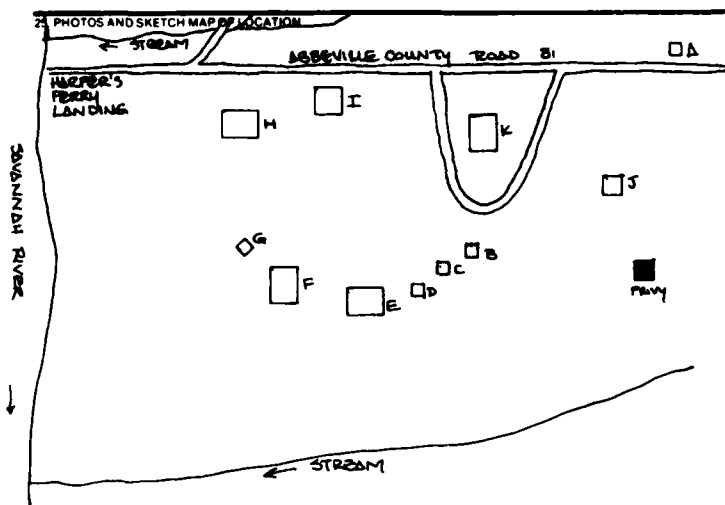
D.
NO MEASUREMENTS TAKEN OF
THIS STRUCTURE, DUE
TO EXTREME OVERGROWTH.

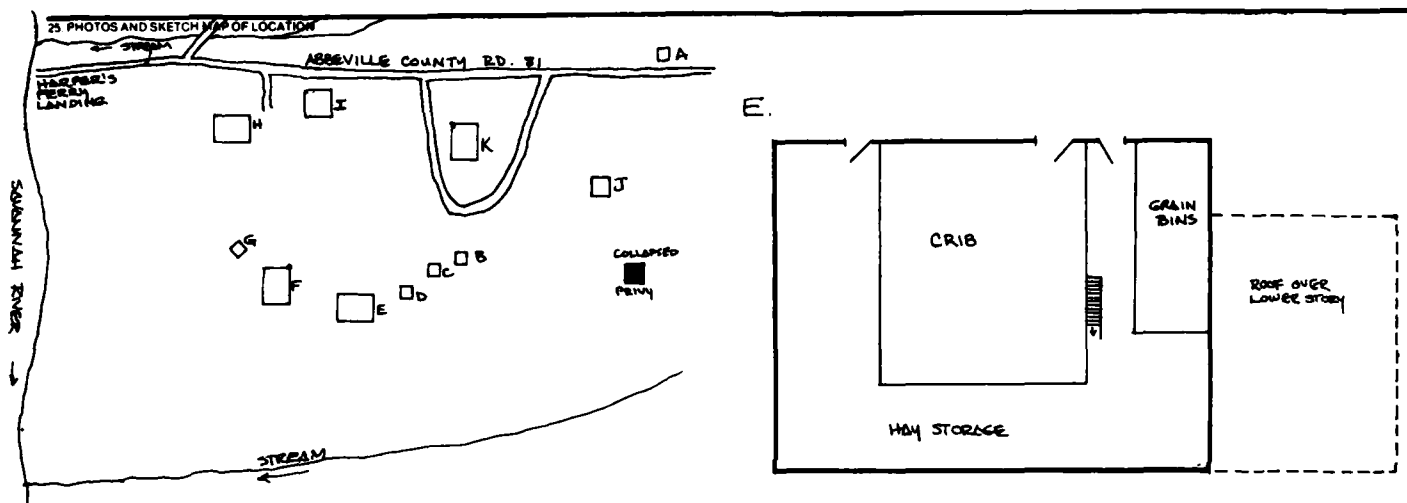
This unusually large barn is one of three embankment structures in the project area. See Site AB1304-A for for significance of complex.

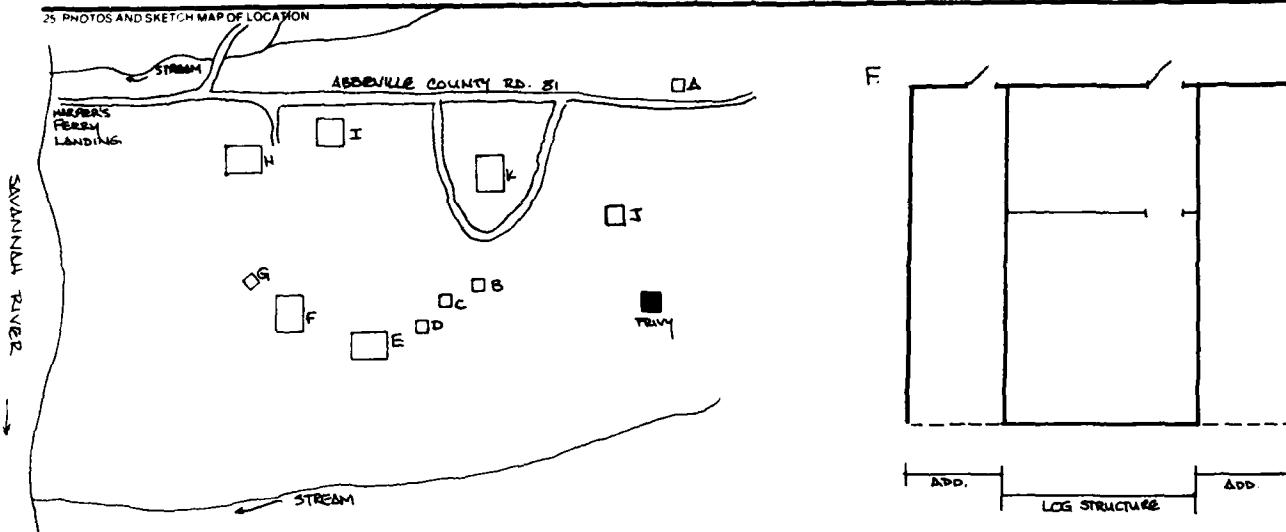
17 DESCRIPTION AND BACKGROUND HISTORY INCLUDING CONSTRUCTION DATE(S); HISTORICAL DATE(S); PHYSICAL DIMENSIONS
MATERIALS EXTANT EQUIPMENT AND IMPORTANT BUILDERS ENGINEERS ETCLog barn with post and frame shed additions, 35' X 32'. Gable and shed roofs covered with sheetmetal; massive logs
hewn on four sides with one-half dovetail joinery, partially covered with sheetmetal, some original hardware intact;
foundations of brick and fieldstone granite piers. Two rooms with loft, used for hay. The structure is well
preserved, due largely to its sheetmetal covering. It is one of ten structures remaining from the Harper Farm
Complex. (See Site AB1304-A for general comments.)

This fine example of early log construction is probably the oldest standing structure in the Harper Farm Complex. Although log barns and other buildings were common in this area in the nineteenth century, this is one of the relatively few examples that survives intact. See Site AB1304-A for significance of complex.

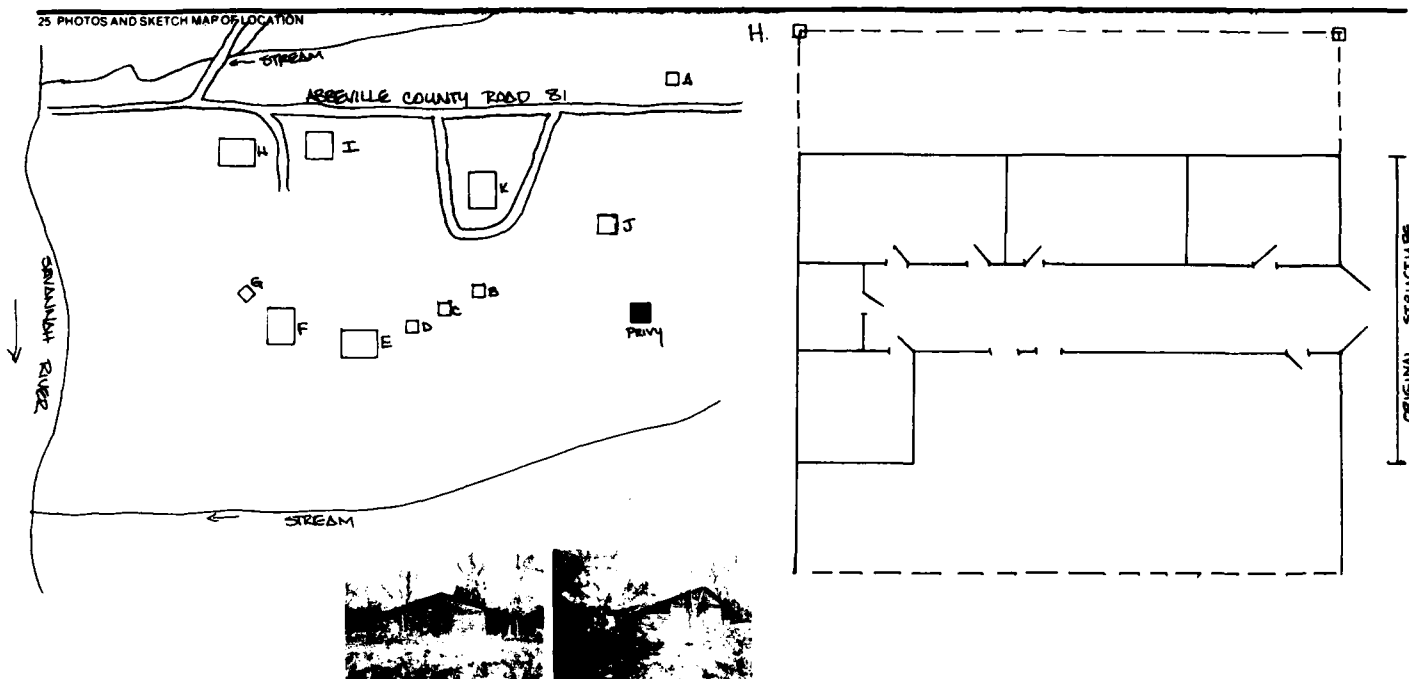
The use of one-half dovetail joinery in constructing frame stalls makes this structure unique. This joinery method was employed in early log construction, but there are no other examples of its use with frame members in the project area, nor has it been documented in the surrounding region. See Site AB1304-A for significance of complex.

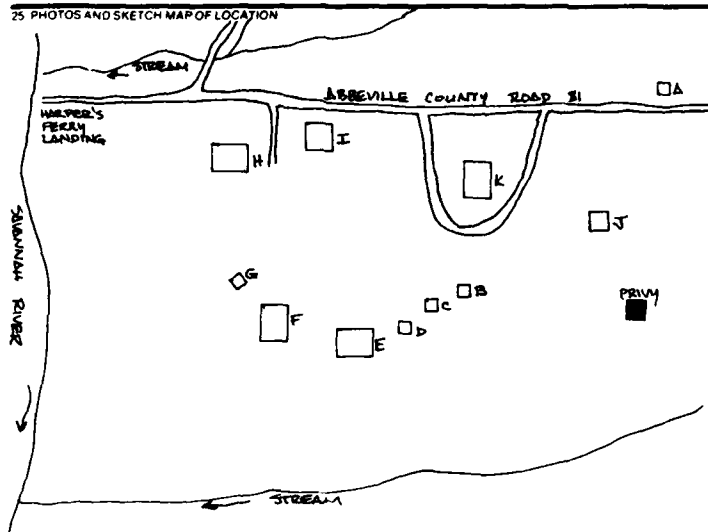
J.
NO MEASUREMENTS TAKEN OF THIS
STRUCTURE DUE TO EXTREME
OVERGROWTH.

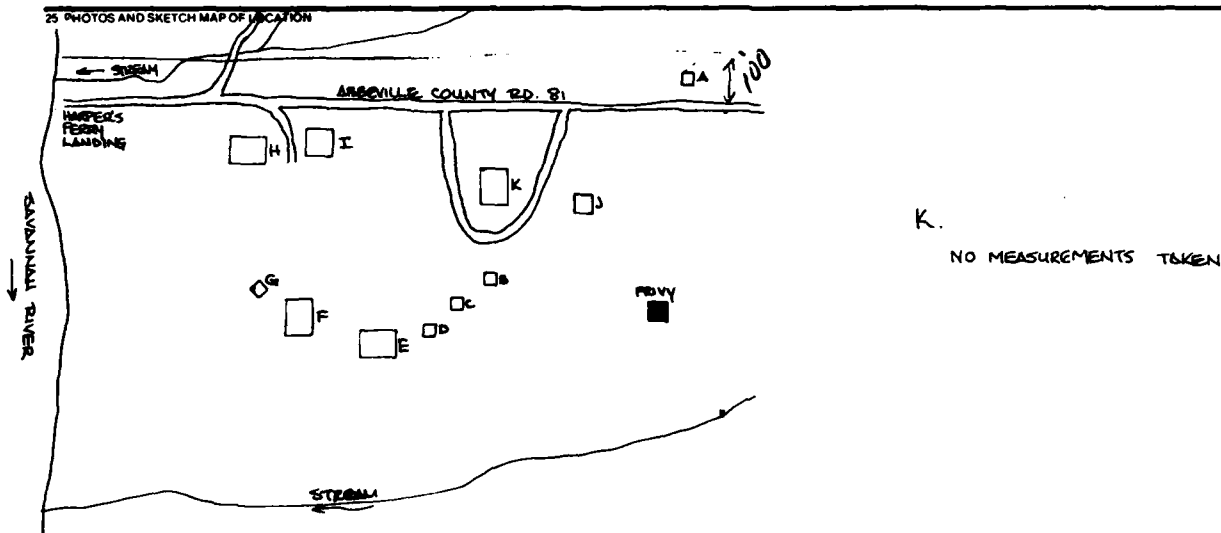
These remains were included in this inventory to lend a sense of completion to the Harper Farm Complex of which ten outbuildings survive. The two chimneys exhibit an unusual construction technique for this region, with a brick relieving arch over the fireplace openings. This is the only known example of this form of brick construction in the project area. See Site AB1304-A for significance of this complex.

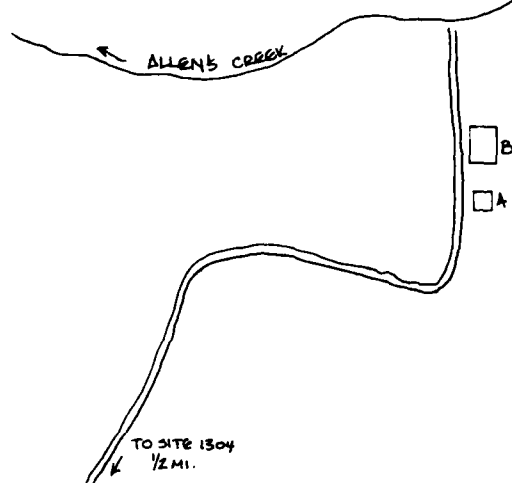
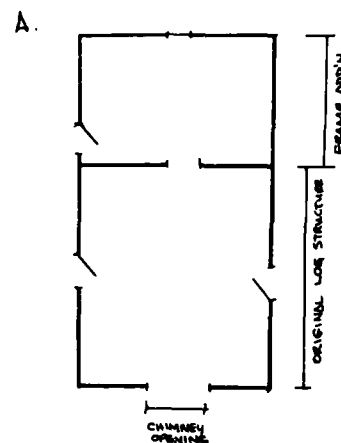
One-story log cabin with frame addition, 32' (two bays) X 18' (one bay). Gable roof covered with sheetmetal, boxed eaves; logs hewn on four sides, one-half dovetail joinery, horizontal battens cover some open spaces between logs, gap in end wall indicates collapsed or removed chimney, windows of no lights covered with board shutters, vertical board door, original door frame pegged into butt ends of logs, clapboard siding on frame addition and gable ends; foundations of massive hewn logs and fieldstone granite piers. Original plan of one room with one room addition. This structure is somewhat deteriorated but restoration and preservation could be accomplished with little difficulty. The structure is associated with a balloon-frame cattle barn, CA. 1940 (Site AB1304-2B), and is probably associated with the Harper Farm Complex (Site AB1304).

Significance
It is possible that this small one-room log cabin was constructed as a slave quarters or other dependency for the Harper Farm (Site AB1304), and later moved to its present location. The age, size and construction methods of the original structure closely parallel those of site AB1304-3A, which may indicate that the two buildings were related and/or had similar uses. The addition to the log structure and its use for hay storage make it a good example of the ways in which farm structures were adapted to changing needs.

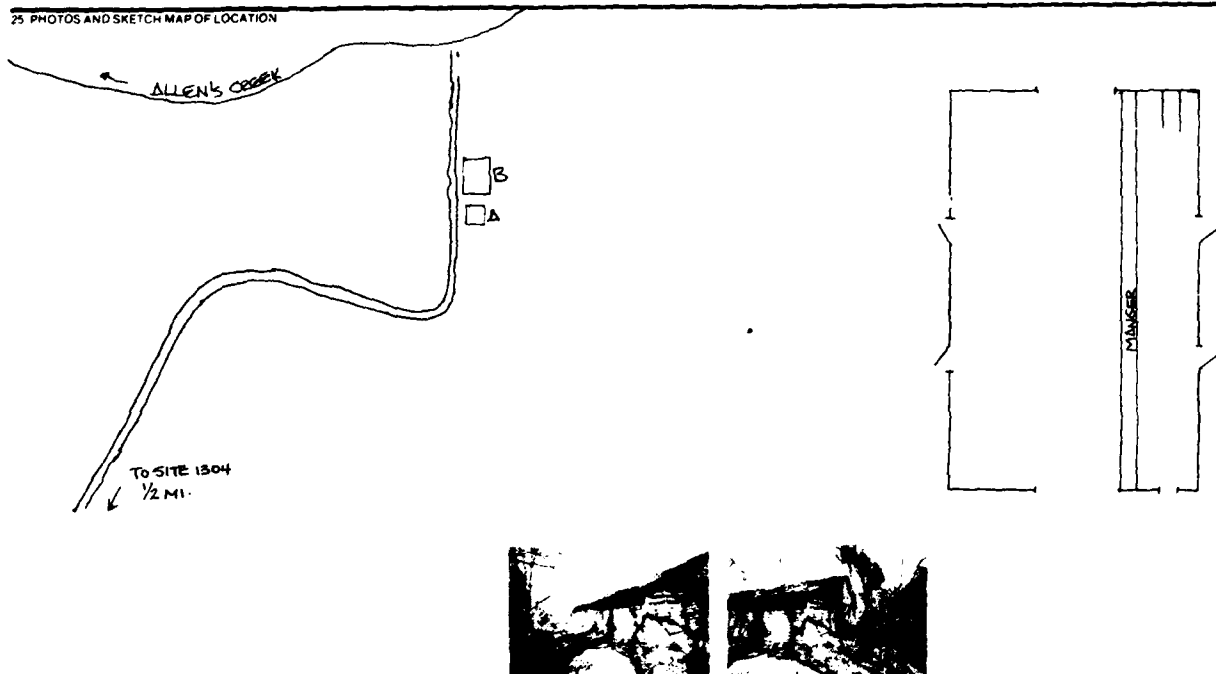
One-story balloon frame cattle barn, 80' X 37'. Gable roof covered with sheetmetal; horizontal board sheathing with boards near eaves spaced for ventilation; foundations of fieldstone granite piers. Interior divided lengthwise into two areas for cattle stalls, manger on one side. This building is relatively well preserved. It is associated with a log cabin converted into a hay barn (Site AB1304-2A), and may be associated with the Harper Farm Complex (Site AB1304).

This structure displays the characteristics of a modern farm outbuilding. Its relationship to Site ABL304-2A, a log cabin adapted as a hay barn and to the Harper Farm Complex, demonstrates the continual evolution of the Southern farm.

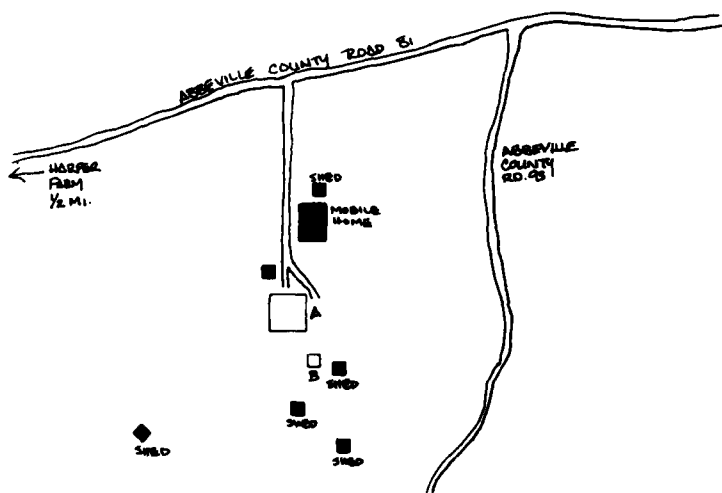
25 PHOTOS AND SKETCH MAP OF LOCATION

Significance
This small dwelling is a fine example of an early one-room log cabin, later adapted for continued use. It is possible that this structure was constructed as a slave quarters or other dependency for the Harper Farm (Site AB1304), and later moved to its present location. The age, size and construction methods of the original structure closely parallel those of Site AB1304-2A, which may indicate that the two buildings were related and/or had similar uses.

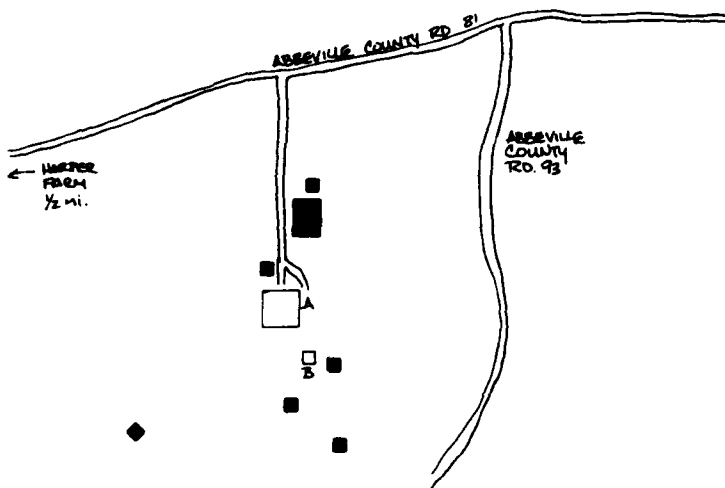
This small shed exemplifies the survival of log construction techniques in the late nineteenth and early twentieth centuries. The late date is indicated by the use of V-notch joinery.

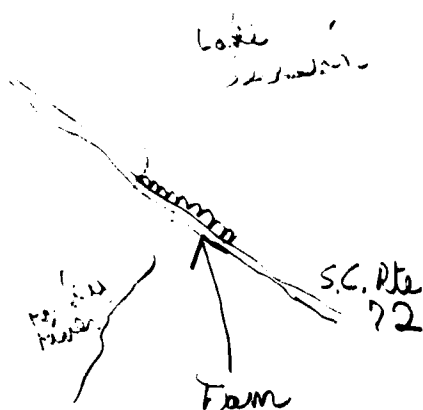
Significance A regionally significant example of multiple arch dam construction. It is the oldest example of this kind of construction in the state. Though not a dam of monumental proportions it is exceptional in terms of water power development in the South.

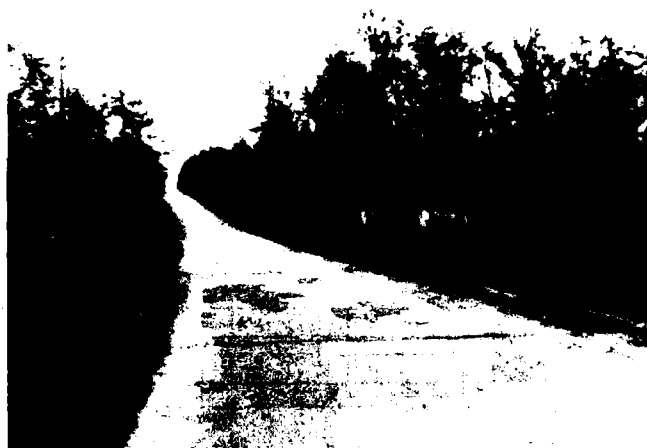
The structure is a single span, bolt connected Warren pony truss. It is 56'5" long and 21'6" wide and rests on reinforced concrete abutments. There are foundations indicating the existence of two early bridges, both of which have been demolished.

Significance A locally significant example of an early 20th century bolted Warren pony truss. It has played a role in the local travel and commerce of the area.
